Evaluation of Ablators for Use in the Ares I Upper Stage Thermal Protection System

Jeff Geldmeier, Virginia Tech

Principal Investigator: Tina Malone, EM10

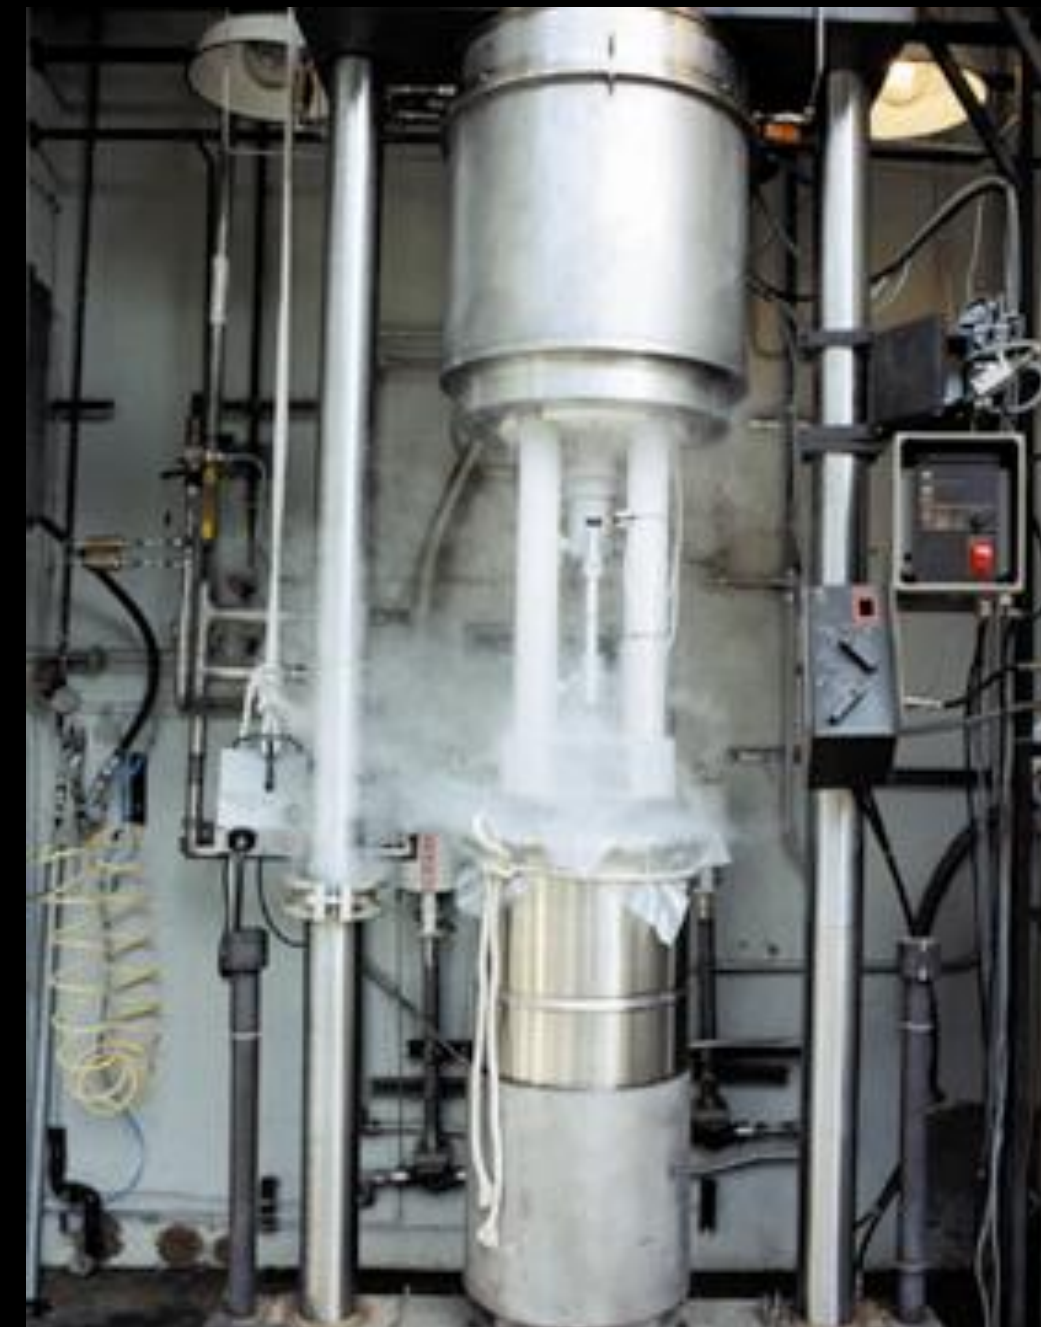
Figure 2: Liquid nitrogen test frame

- Ablator bond tension tests were conducted in a wide range of temperatures to simulate actual conditions aboard a spacecraft. Three specimens of each ablator were tested in each of the following four environments:
 - Liquid nitrogen (-320 °F, see Figure 2 above)
 - Gaseous nitrogen (-200 °F)
 - Room temperature air (75 °F)
 - Elevated temperature air (250 °F)
- Actual temperatures and actual dimensions of the samples were recorded prior to testing.
- Samples were then mounted in test frames. See Figure 2 above for a standard liquid nitrogen test frame and Figure 3 below for a room temperature test setup.
- Test specimens were pulled at a rate of 0.050 inches per minute, and data was collected at an acquisition rate of 5 Hertz (5 points per second).
- Samples were pulled until failure was reached and the blocks separated.

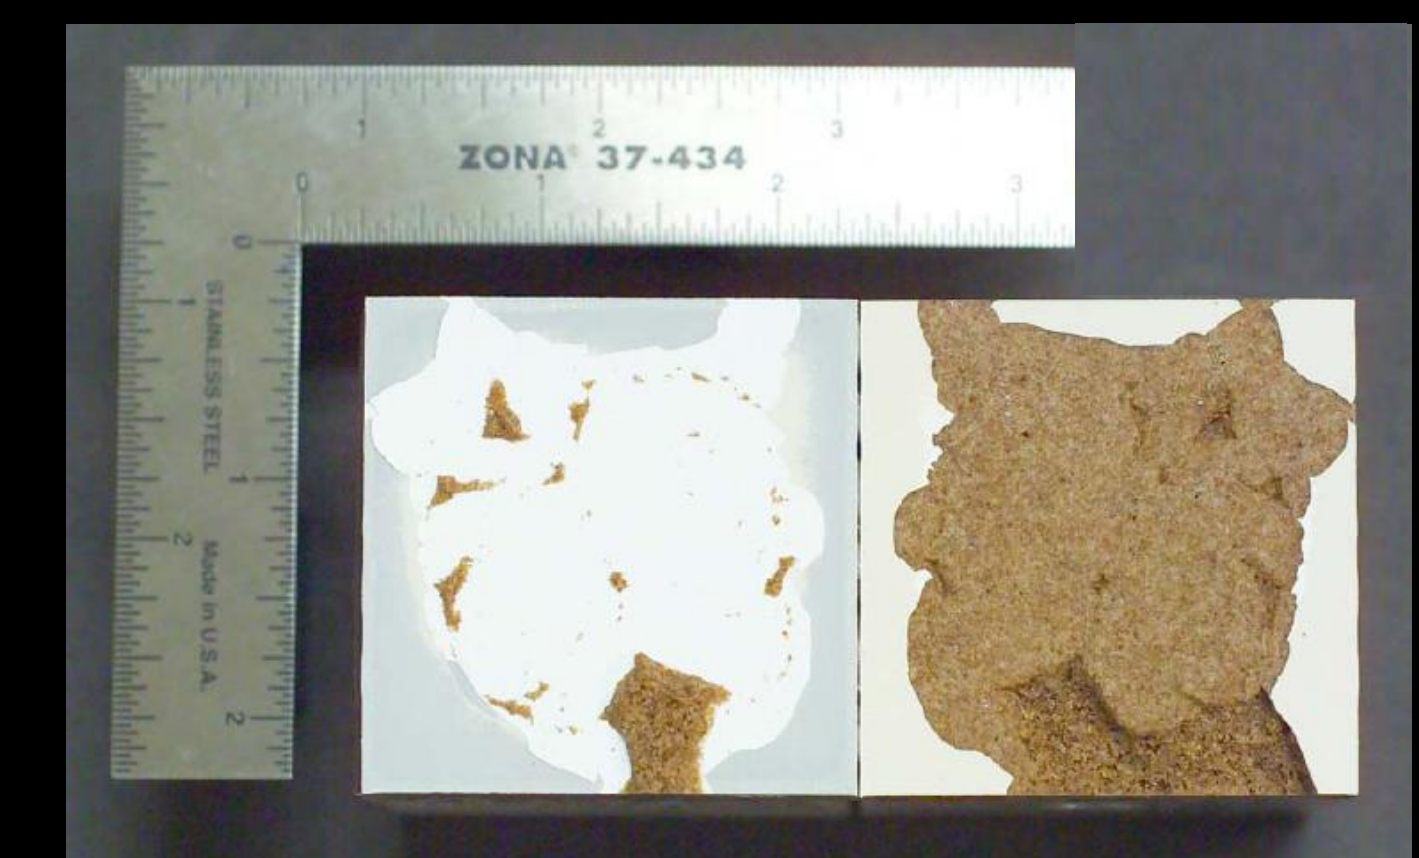
Figure 4: A broken MCC-1 test sample that exhibits all three kinds of failure

- Test samples failed by cohesive failure of the ablator, adhesive failure between the ablator and the primer, adhesive failure between the ablator and the substrate, or a combination of the above (Figure 4).
- The ultimate load the specimen was able to hold (Figure 5) was divided by the initial cross-sectional area to determine the bond adhesion tensile strength.
- All ablator candidates performed well above the minimum requirements of the test.
- MCC-1 performed notably better than the other candidates in the bond tension test. The TMC SP1 formulation was the next best performer, followed by the TMC SP2 formulation and lastly by the P50 cork.*

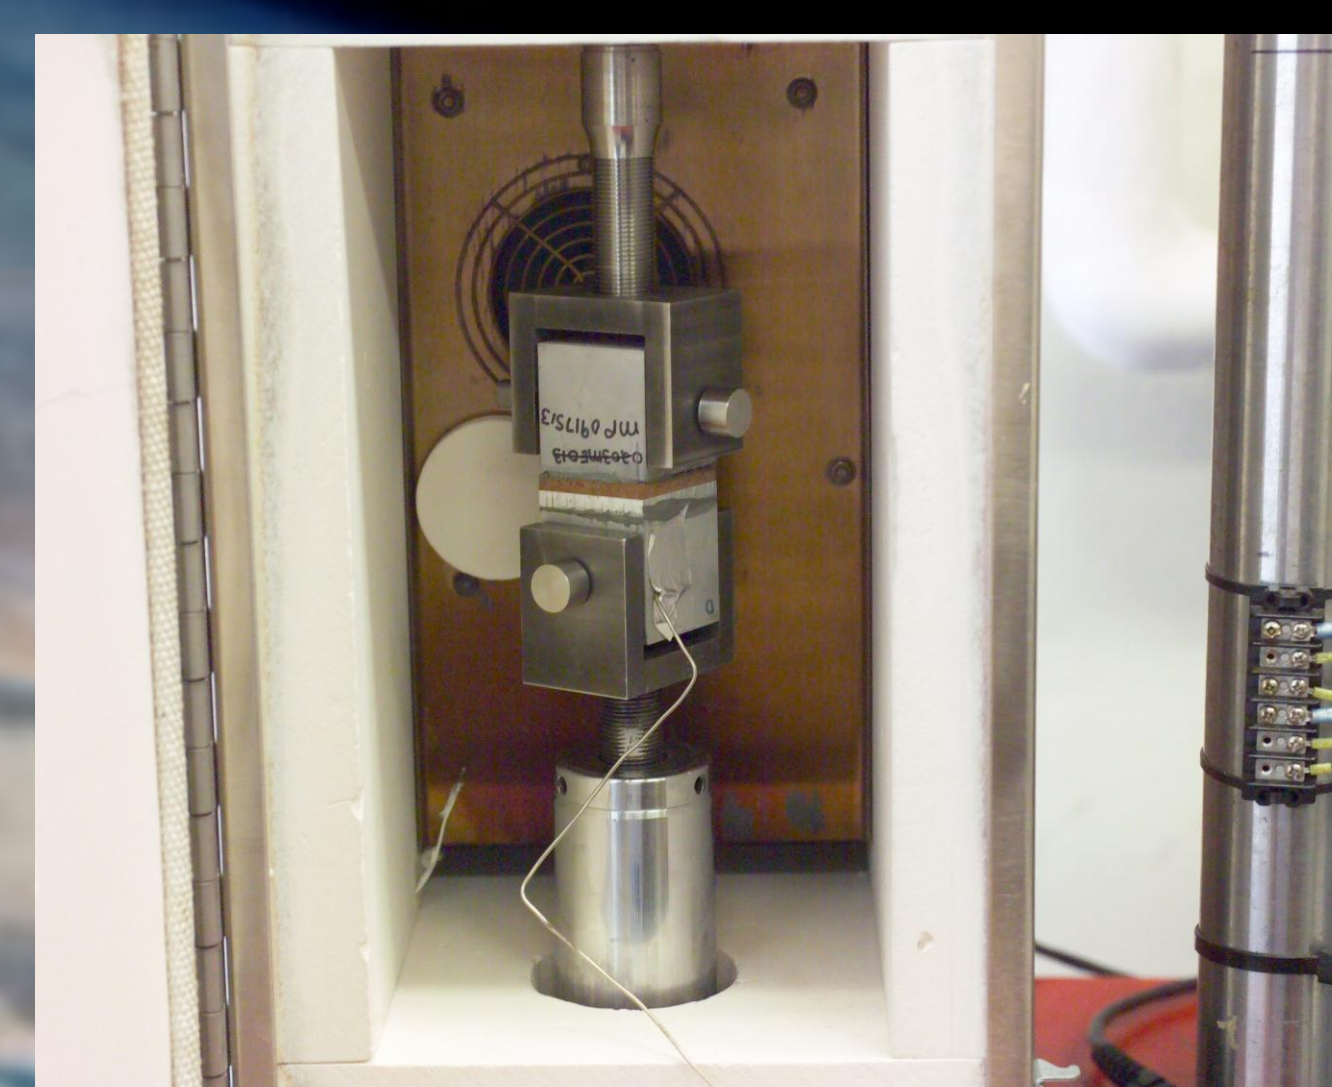
Figure 3: A test sample mounted for room temperature testing
